Manhole Inspection Summary

Manhole # S25OO1002MH

Location Address: **4705 ROLAND AVE**

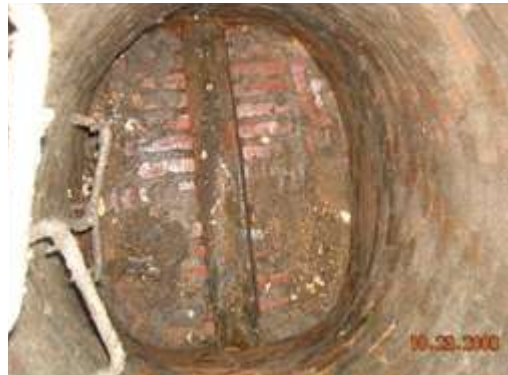
Top View

Surcharge ☒ **Evidence Of Surcharge** Depth: **3** (ft.) ☐ Active Surcharge Present

Evidence of surcharge - Bench debris.

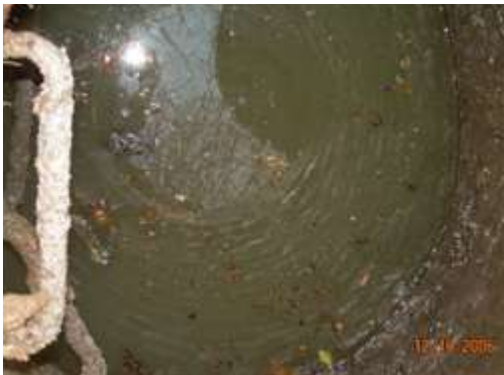
Top View

Active surcharge - 1st vist. Needs cleaning

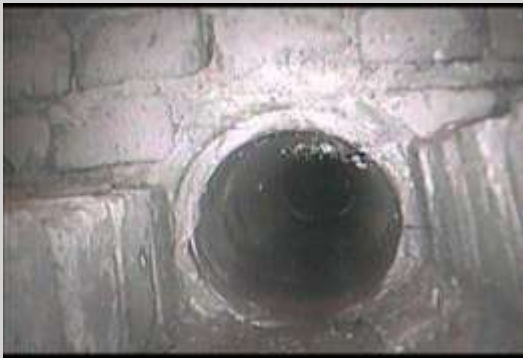
8 in. Circular Gravity Sewer Pipe Out @ 12 O'Clock

Pipe Material: **Clay** ☐ Pipe Lined

Invert Depth: **6.75** (ft.) Flow Characteristics: **Slow**

Infiltration: **None** Pipe Seal Cond: **Unknown**

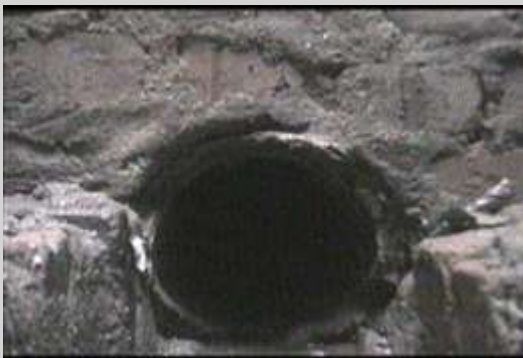
8 in. Circular Gravity Sewer Pipe In @ 6 O'Clock

Pipe Material: **Clay** ☐ Pipe Lined

Invert Depth: **6.72** (ft.) Flow Characteristics: **Slow**

Infiltration: **Evidence** Pipe Seal Cond: **Broken**
